RE:WATER RIGHTS VALIDATION

Thank you for contacting WaterBank to conduct a Water Rights Validation on the specified properties in Valencia County, New Mexico being designated Middle Rio Grande Conservancy District (MRGCD) Map 85, A2, A3, and A4 Land of Trinidad Romero. A Water Rights Validation offers the client an in-depth analysis of irrigated land and offers a conclusion based on the findings. We must point out that any final determination lies with the Office of the New Mexico State Engineer.

MRGCD Map No. 85

Tracts: A2, A3, and A4 Land of Trinidad Romero

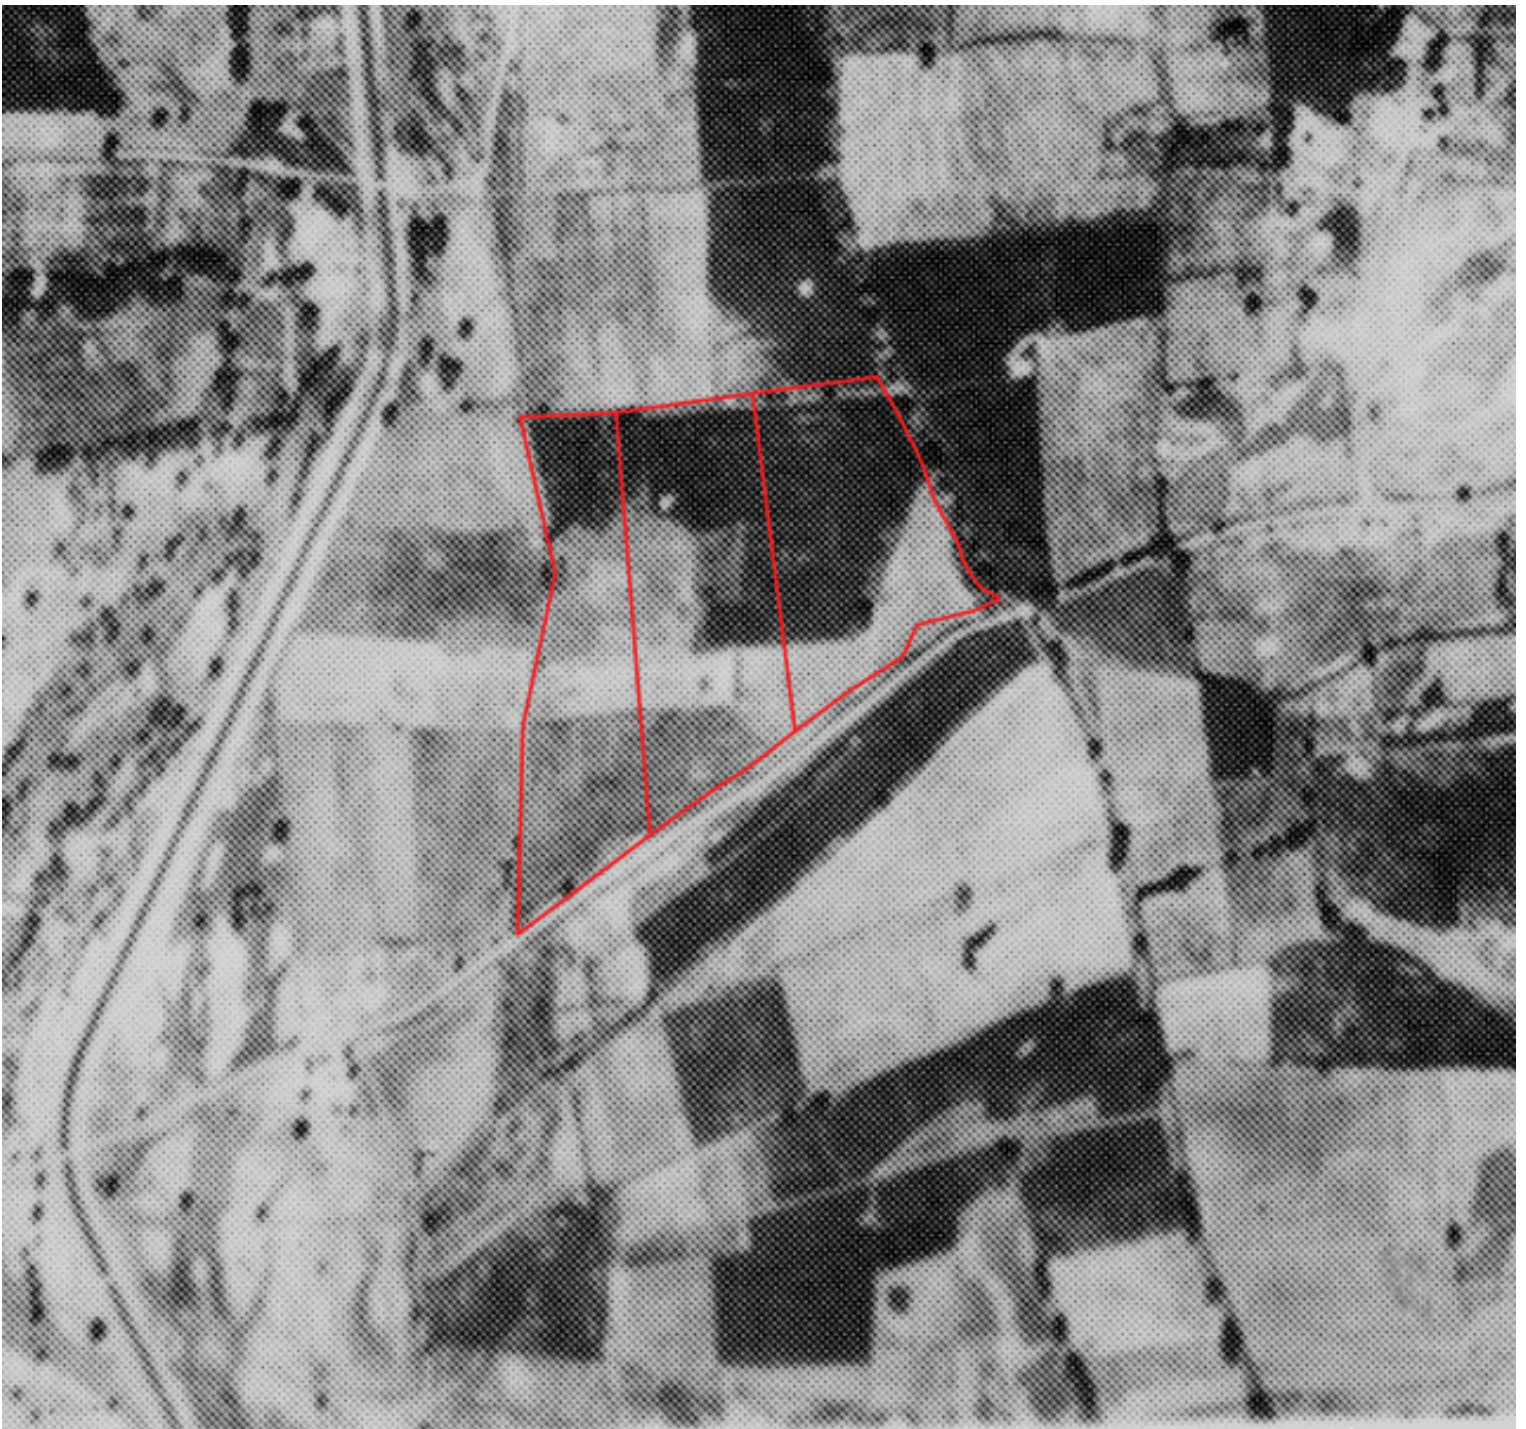
Exhibit F

These Tracts show clear evidence of irrigation on the 1935 aerial photograph. This meets the NMOSE's third criteria for a valid pre-1907 surface-water right.

1935 Aerial Photograph
MRGCD Map 85, Tracts A2, A3, and A4 Land of Trinidad Romero
Red box outlines subject tracts

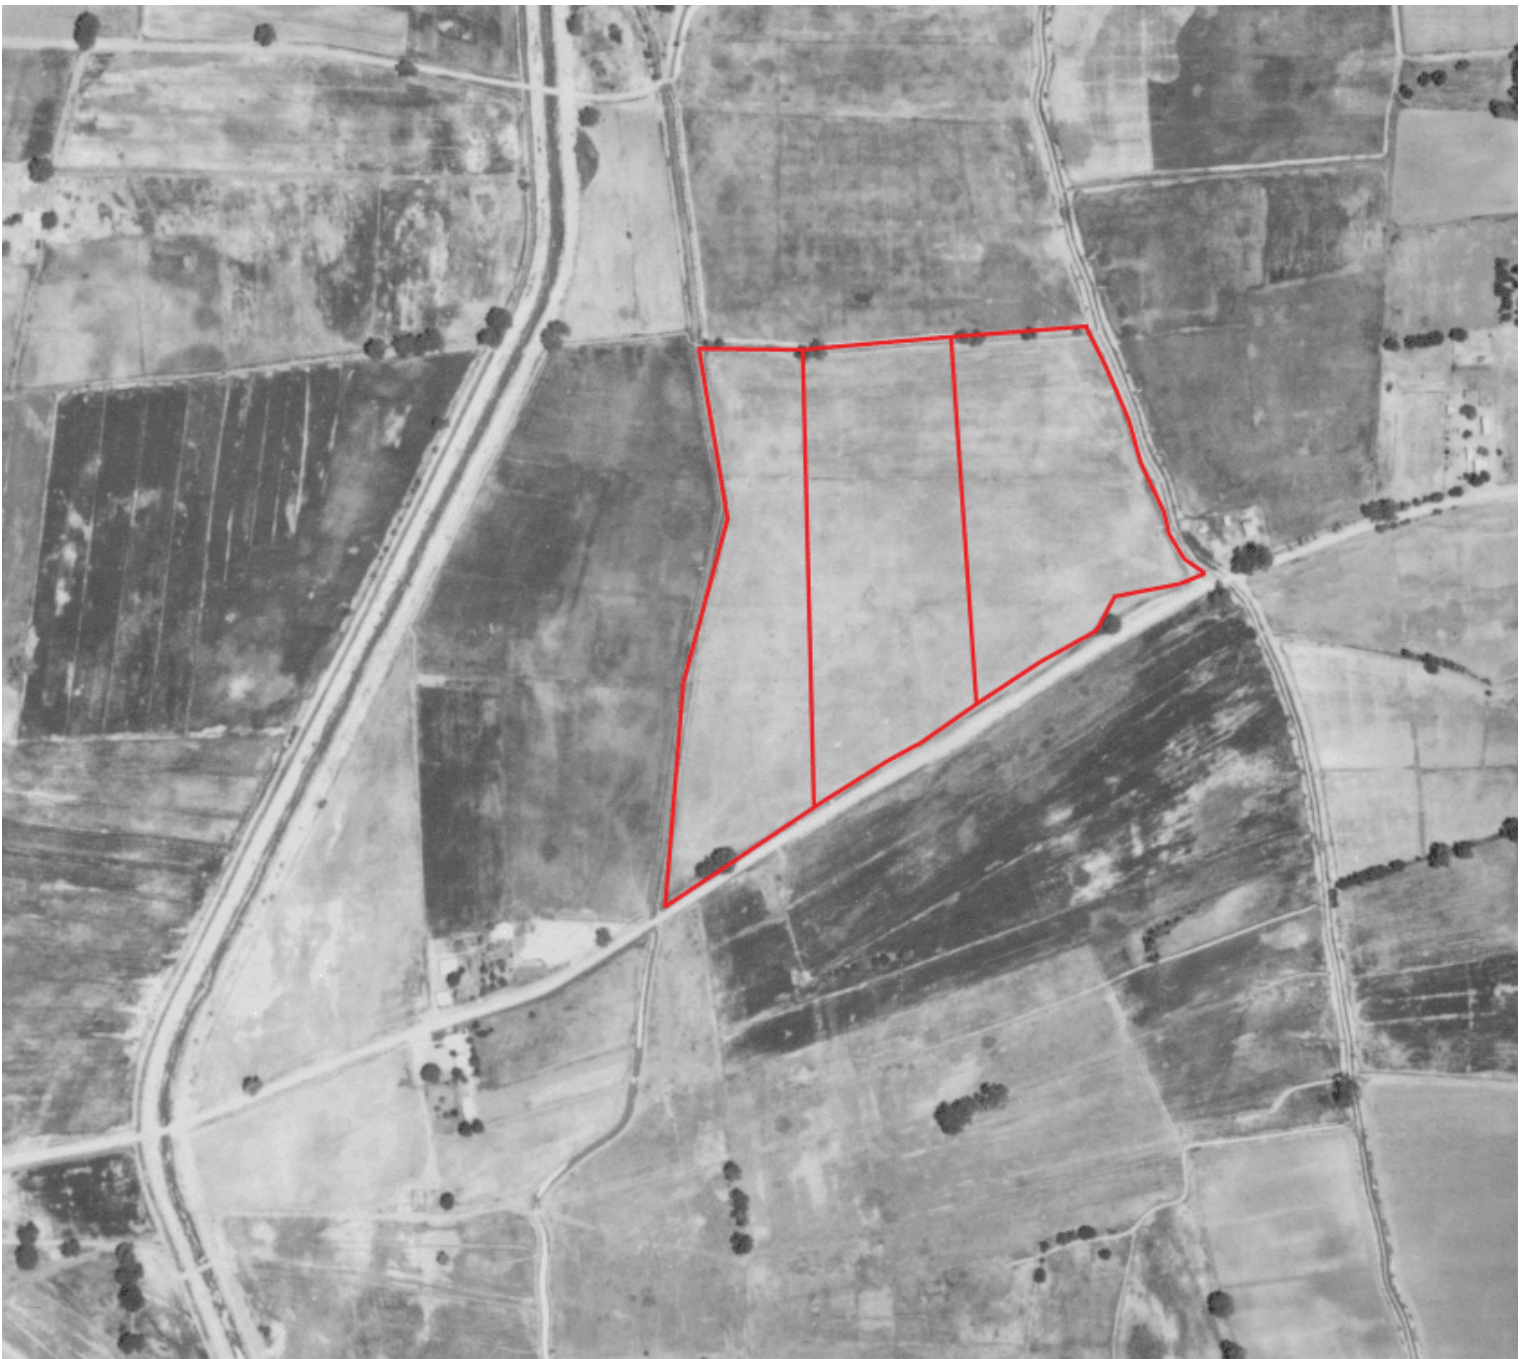
Exhibit H

These Tracts show clear evidence of irrigation on the 1955 aerial photograph. This meets the NMOSE's criteria for continuing cultivation.

1955 Aerial Photograph
MRGCD Map 85, Tracts A2, A3, and A4 Land of Trinidad Romero
Red box outlines subject tracts

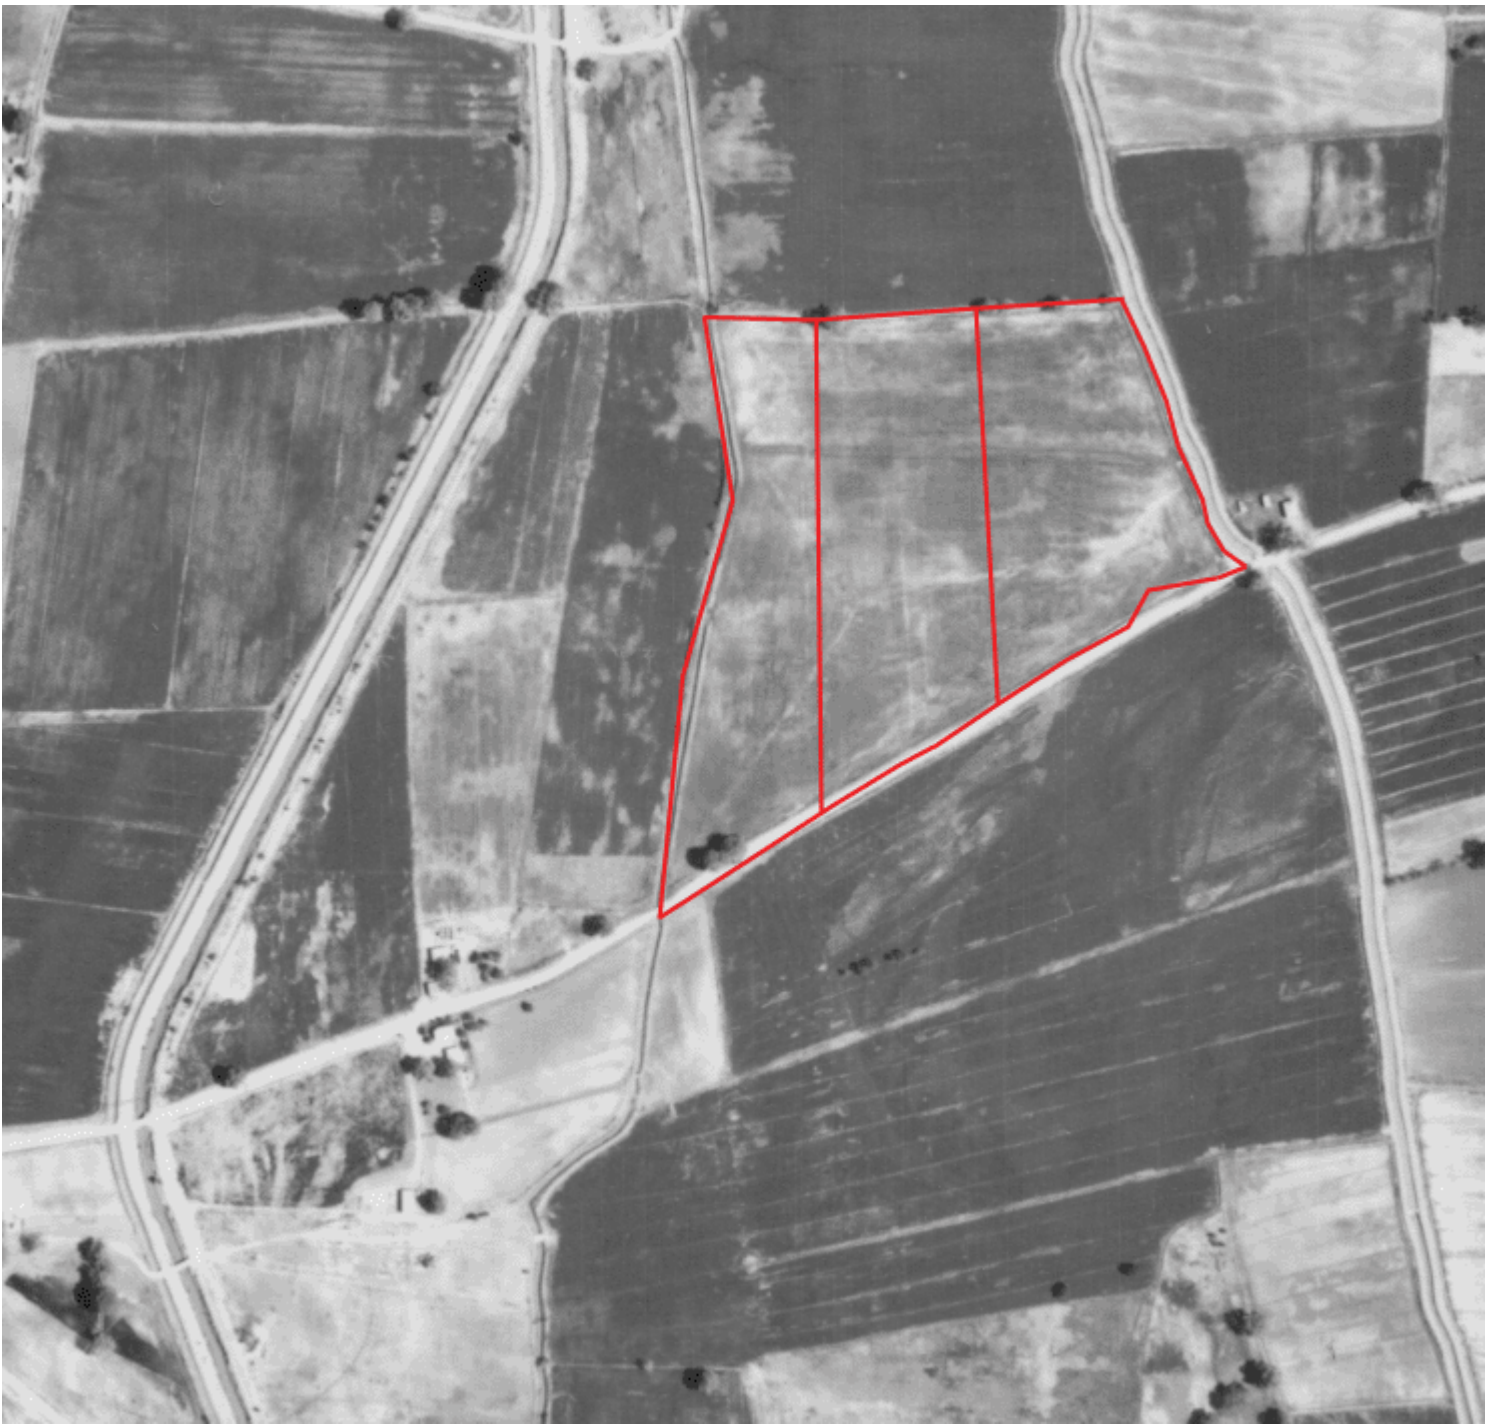
Exhibit I

These Tracts show clear evidence of irrigation on the 1963 aerial photograph. This meets the NMOSE's criteria for continuing cultivation.

1963 Aerial Photograph
MRGCD Map 85, Tracts A2, A3, and A4 Land of Trinidad Romero
Red box outlines subject tracts

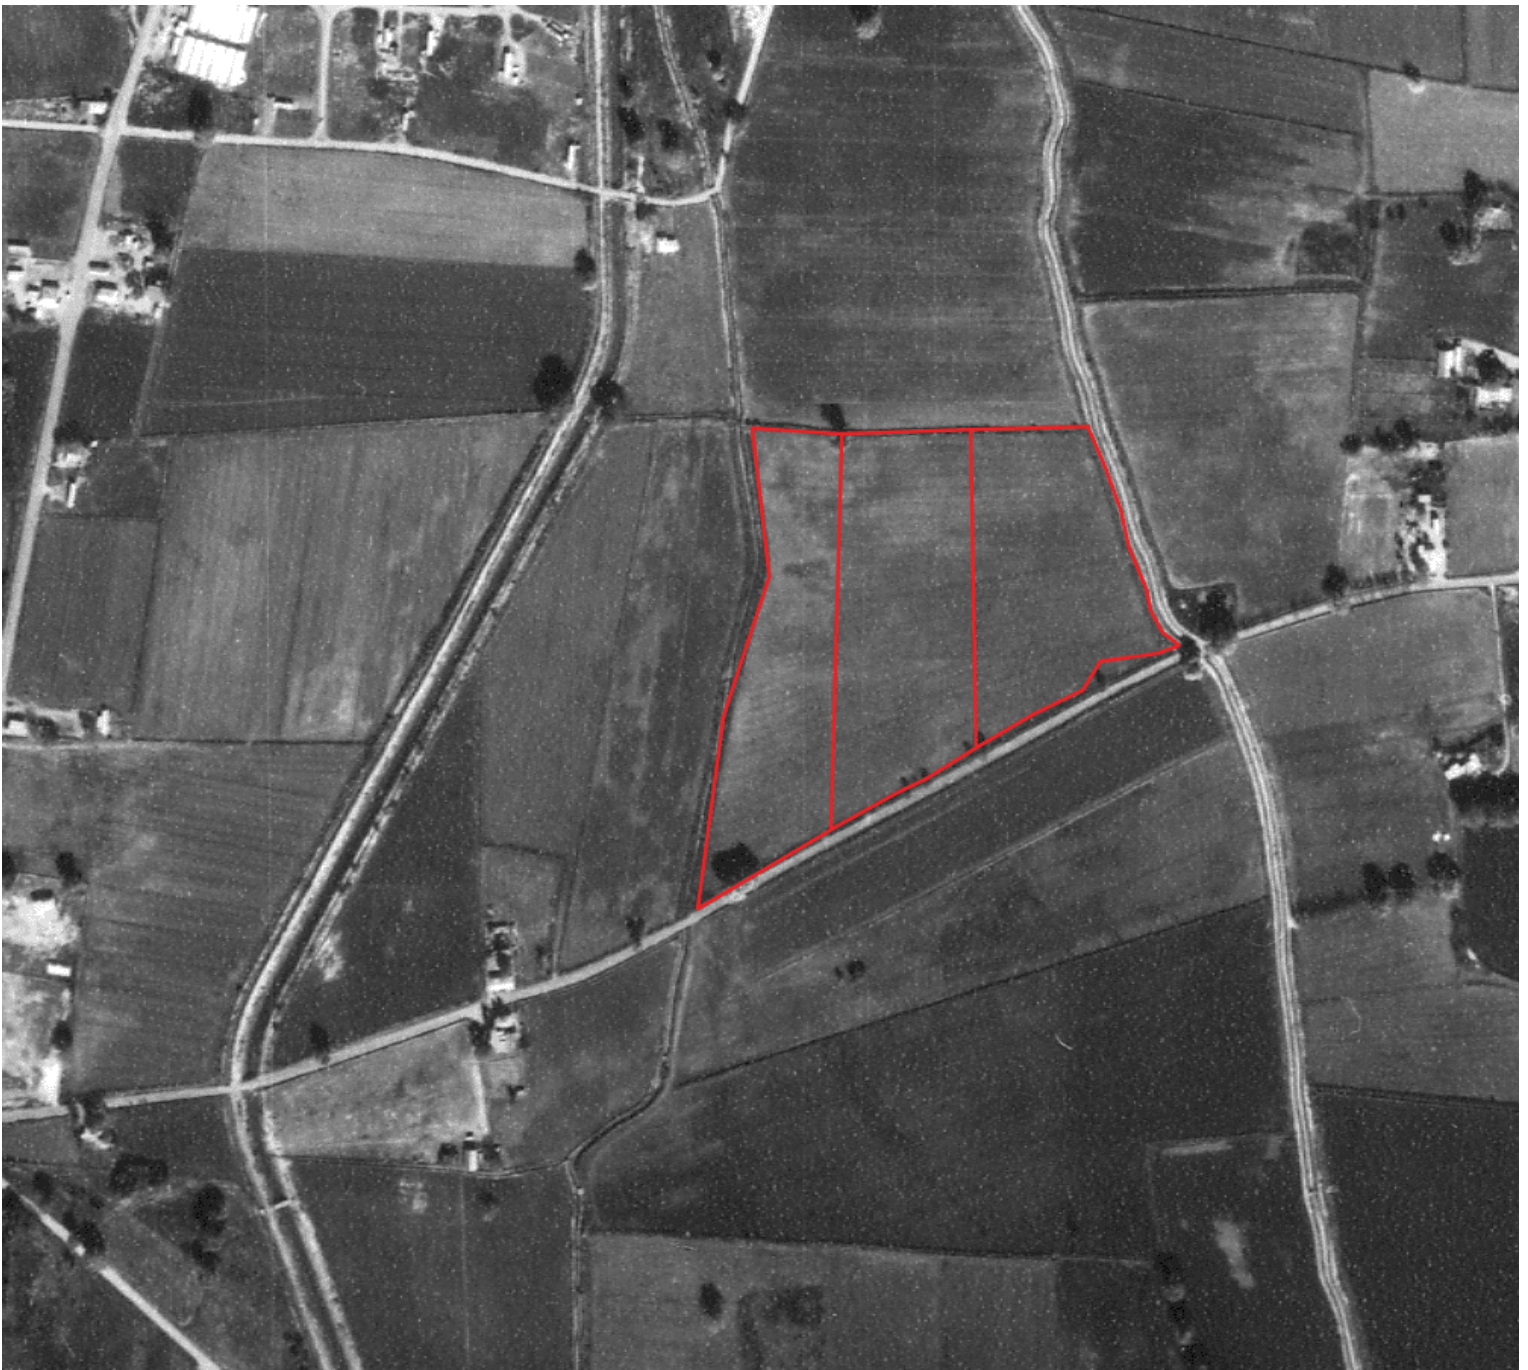
Exhibit J

These Tracts show clear evidence of irrigation on the 1974 aerial photograph. This meets the NMOSE's criteria for continuing cultivation.

1974 Aerial Photograph
MRGCD Map 85, Tracts A2, A3, and A4 Land of Trinidad Romero
Red box outlines subject tracts

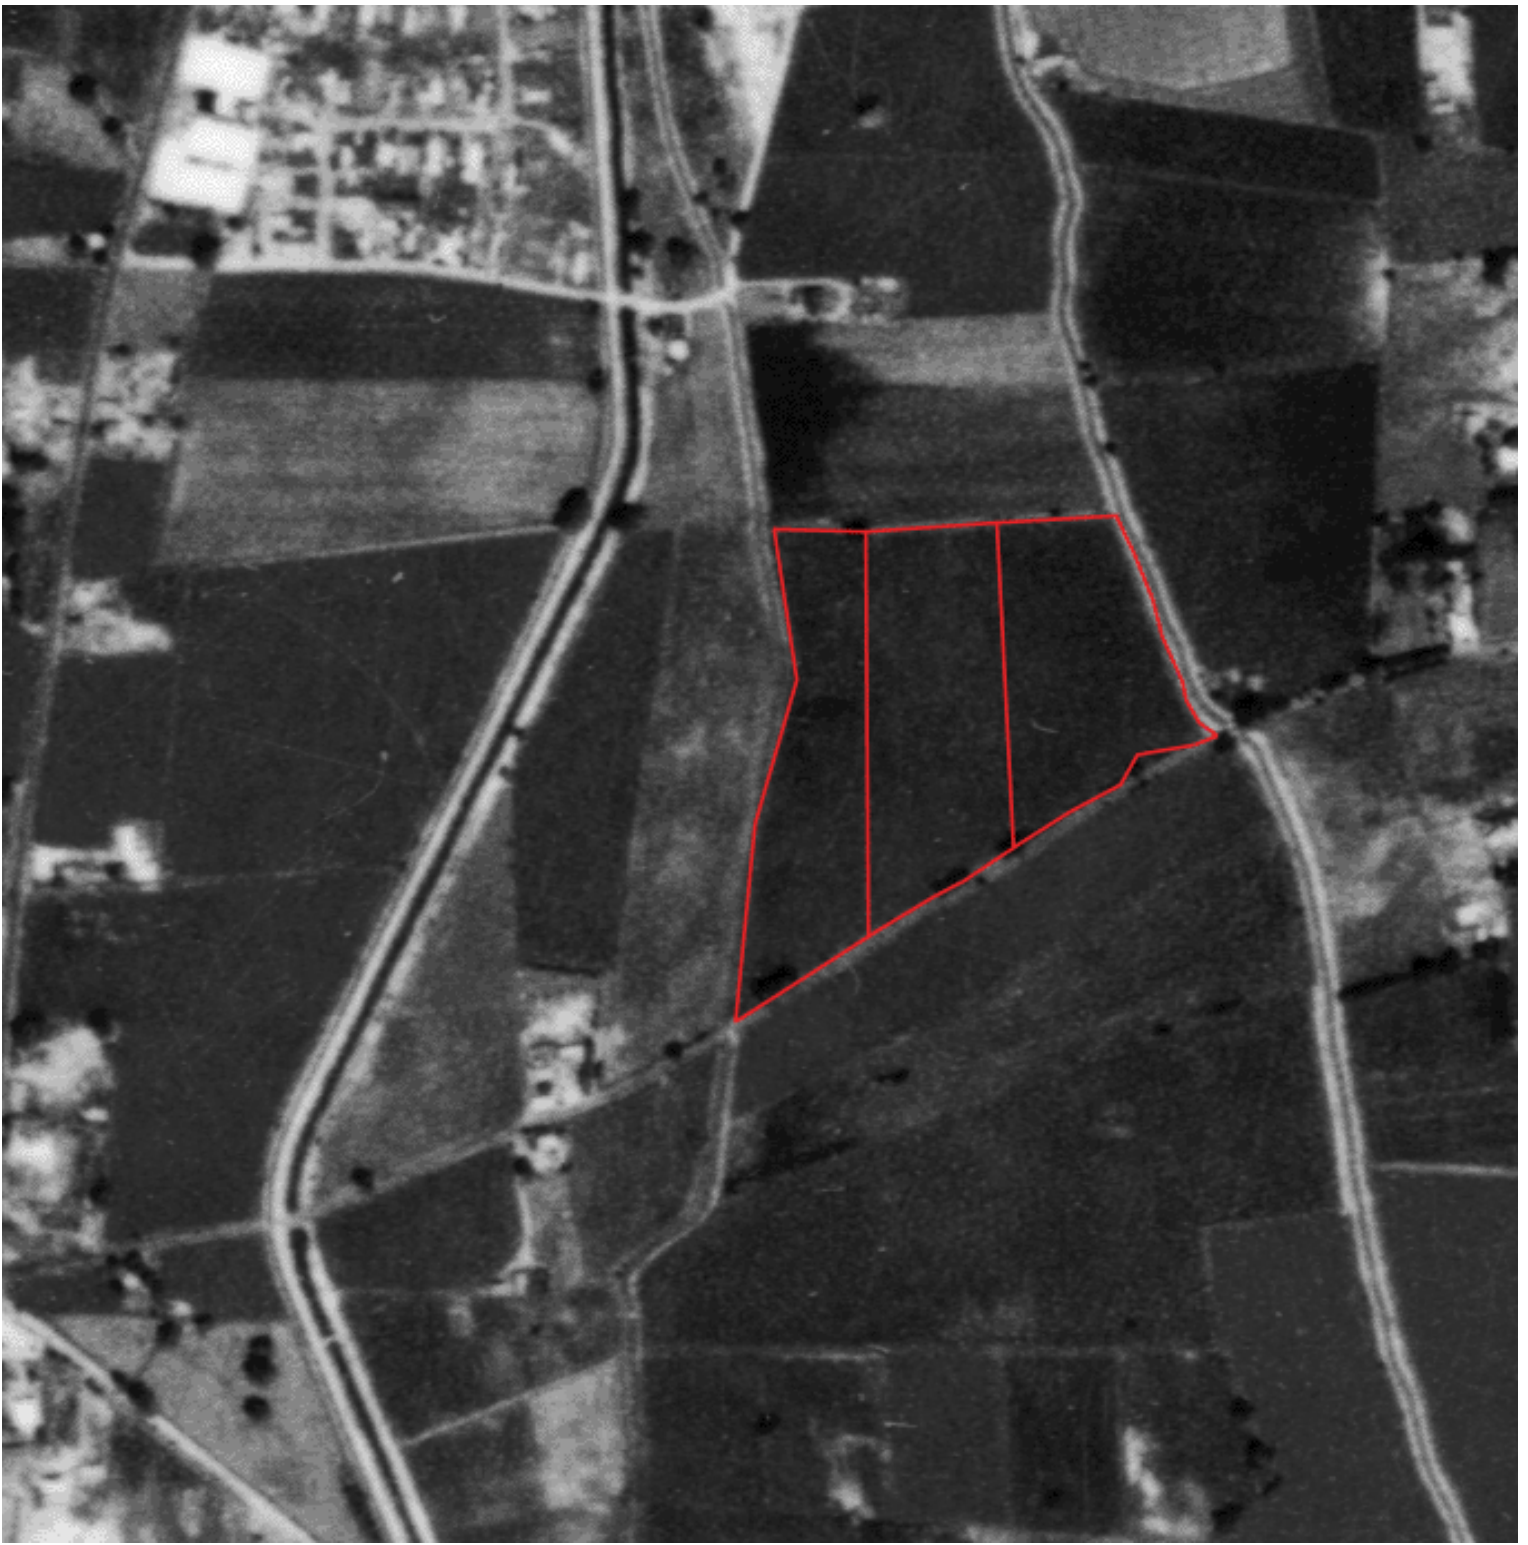
Exhibit K

These Tracts show clear evidence of irrigation on the 1984 aerial photograph. This meets the NMOSE's criteria for continuing cultivation.

1984 Aerial Photograph
MRGCD Map 85, Tracts A2, A3, and A4 Land of Trinidad Romero
Red box outlines subject tracts

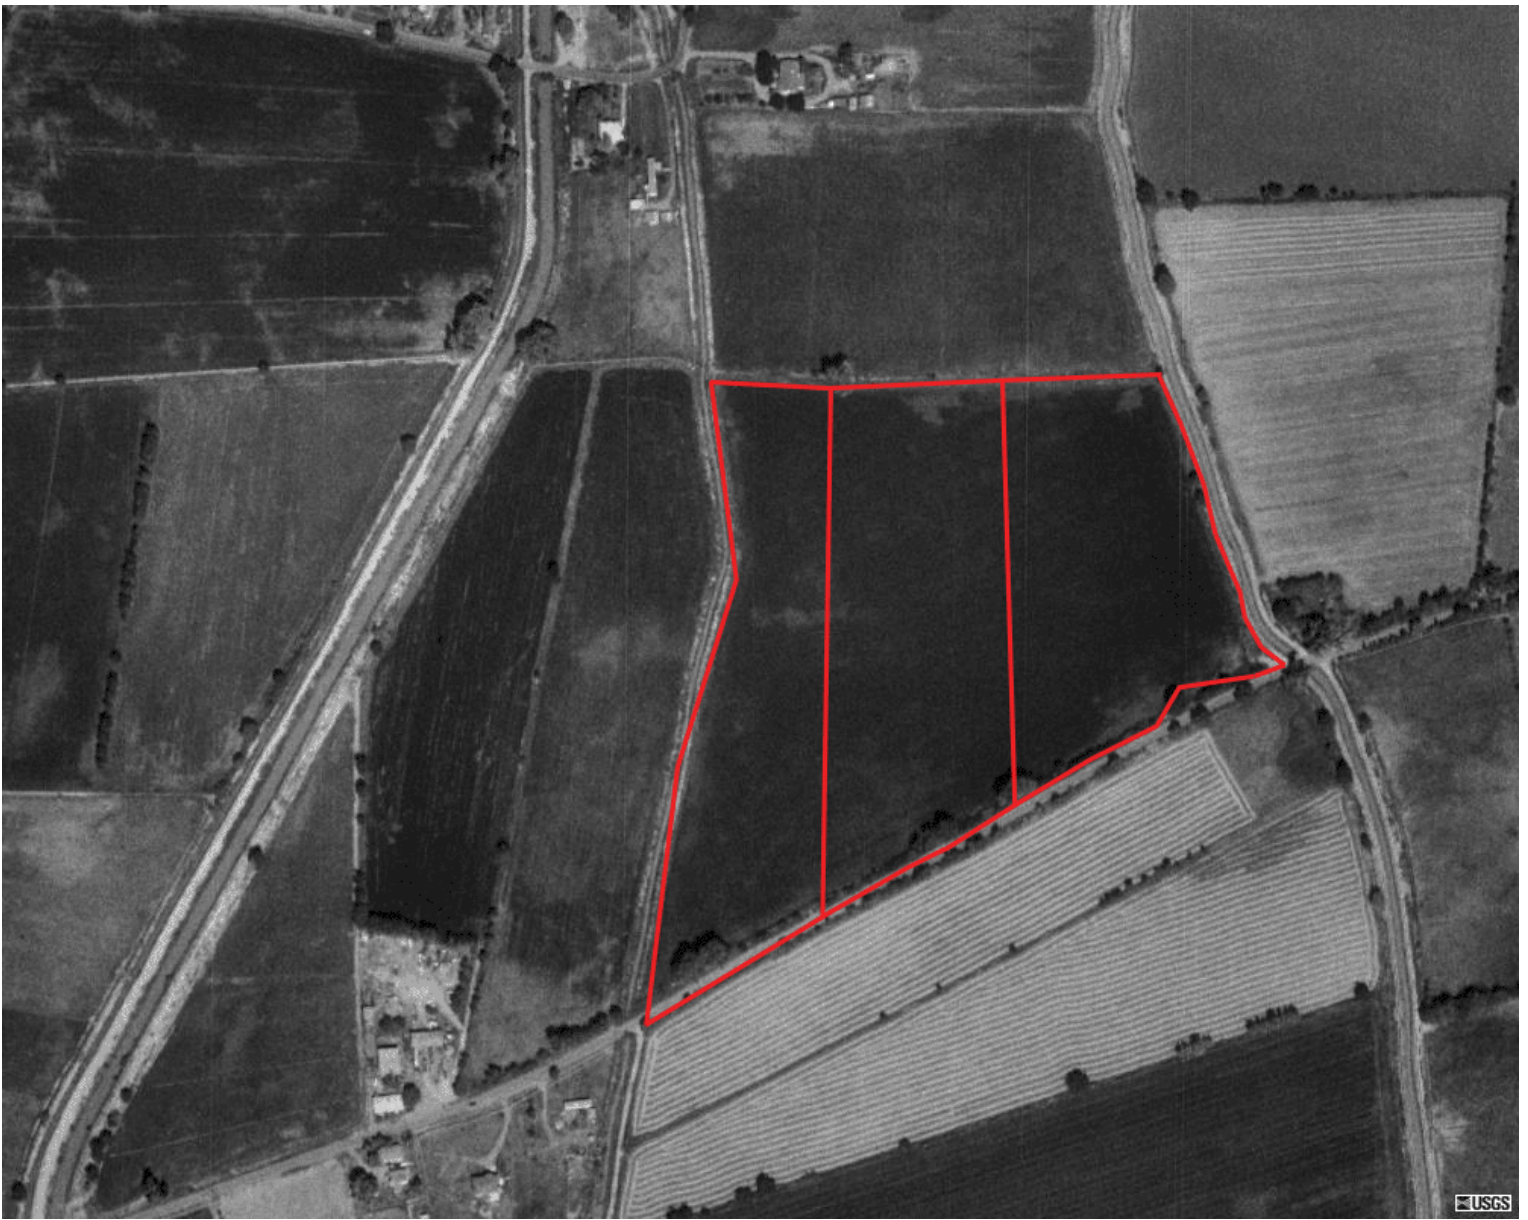
Exhibit L

These Tracts show clear evidence of irrigation on the 1996 aerial photograph. This meets the NMOSE's criteria for continuing cultivation.

1996 Aerial Photograph
MRGCD Map 85, Tracts A2, A3, and A4 Land of Trinidad Romero
Red box outlines subject tracts

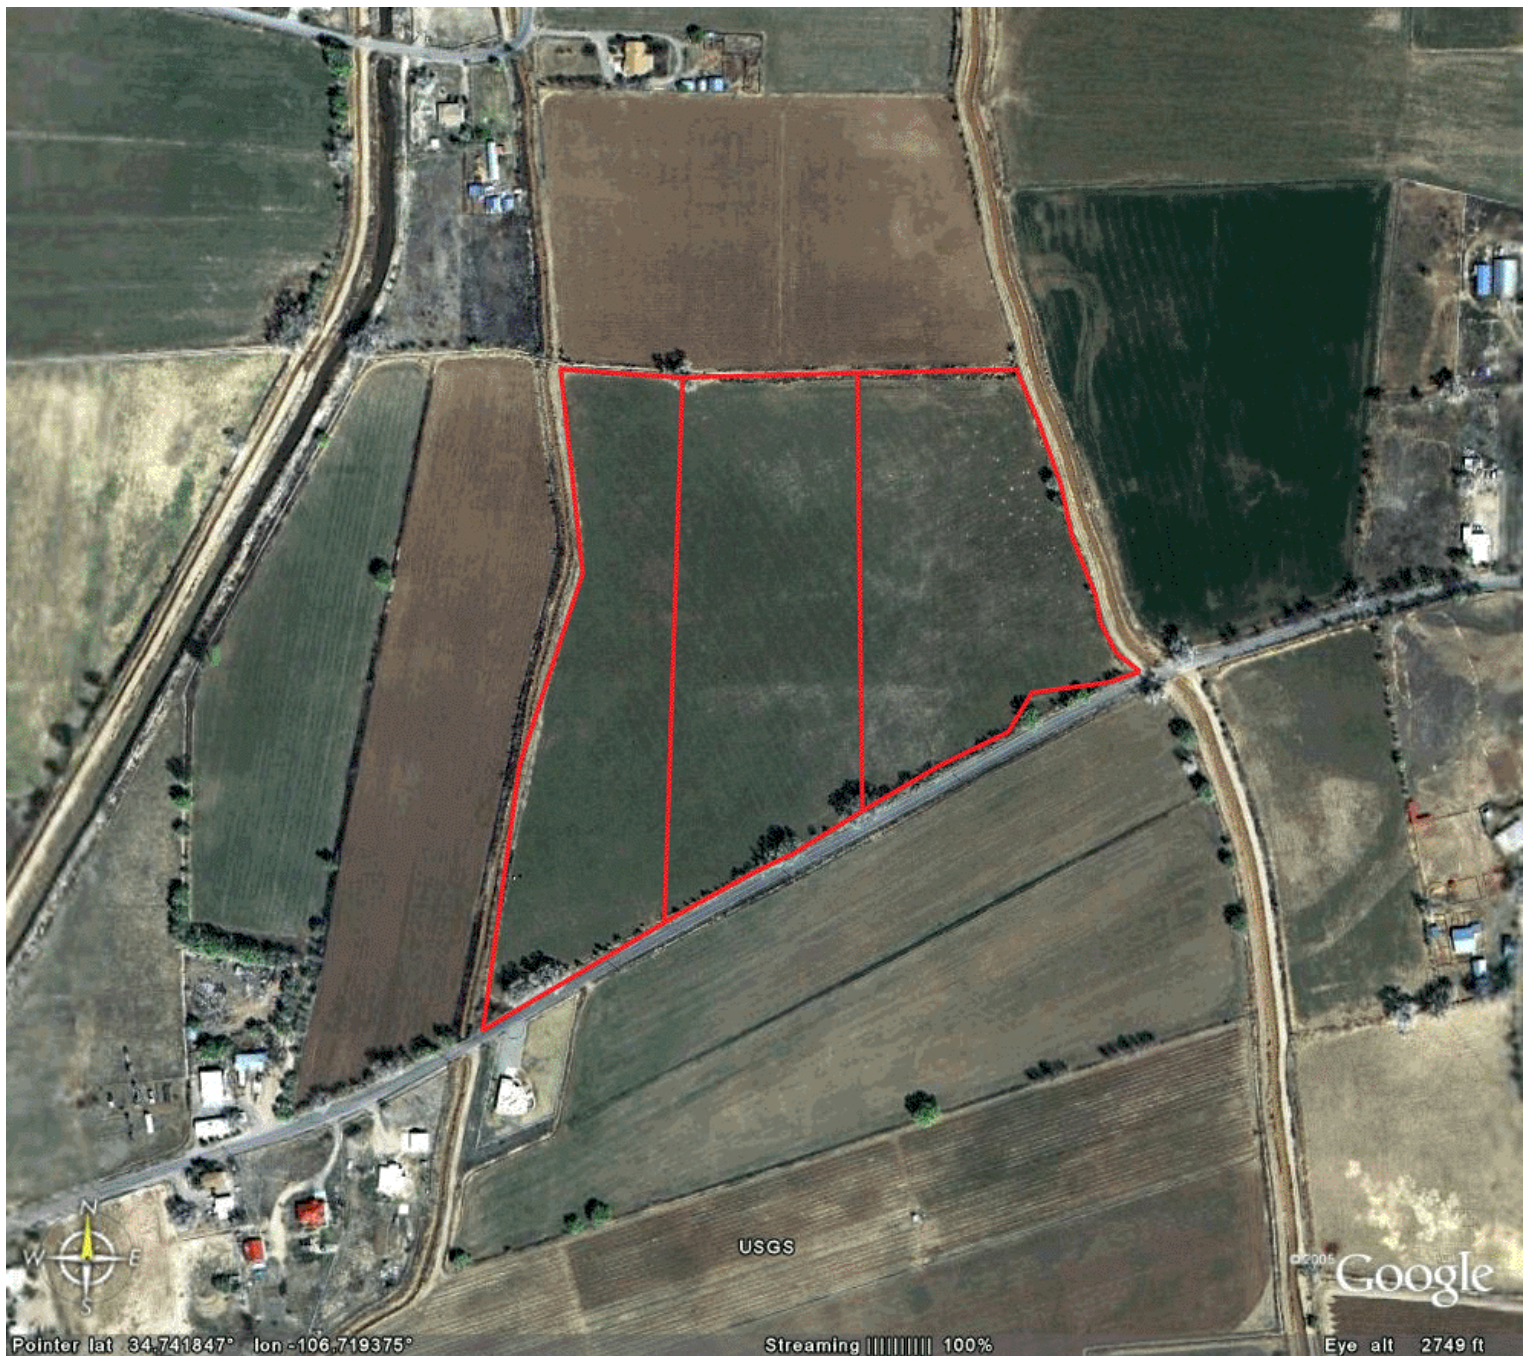
Exhibit M

These Tracts show clear evidence of irrigation on the 2002 aerial photograph. It meets the NMOSE's criteria for continuing cultivation.

2004 Aerial Photograph
MRGCD Map 85, Tracts A2, A3, and A4 Land of Trinidad Romero
Red box outlines subject tracts
